IAEA MISSION ON PARTIAL COLLAPSE OF TURBINE HALL ROOF OF UNIT 4

**Chernobyl NPP, Ukraine
03–07 June 2013**

**Review of activities performed by ChNPP and analyses of perspective causes of
the Unit 4 turbine roof failure.**

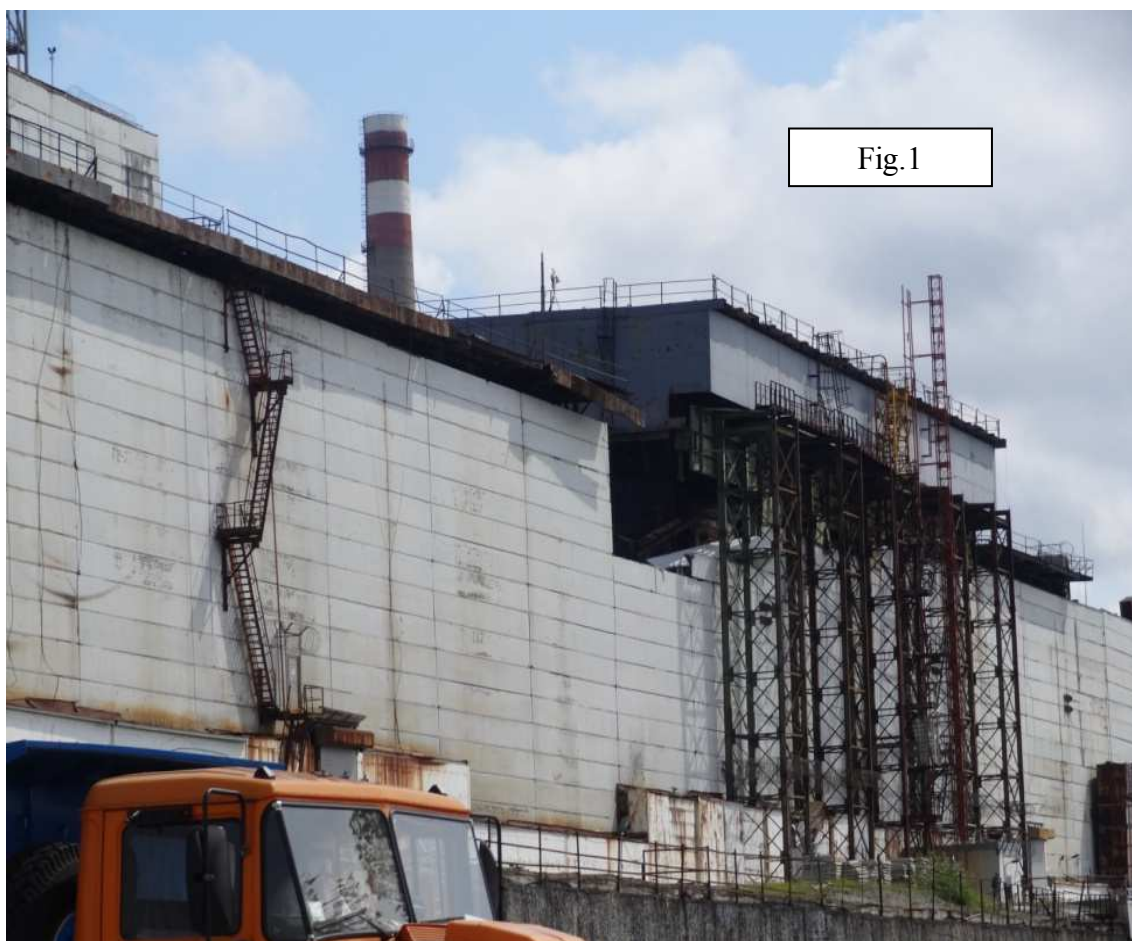
The collapse of the part of the Chernobyl NPP's Unit 4 Turbine Hall roof in axes 50-52 has occurred 12.02.2013 (Figure 1). The survey conducted after the collapse showed that the failure of the truss along gridline 50 (Figure 2) was the cause of the collapse. Truss failure resulted in the collapse of the hinged wall roof panels and additional roof constructions, installed in 1988 above the roof originally constructed in 1983.

Figure 1 Turbine Building outside view of area of collapsed wall and roof section

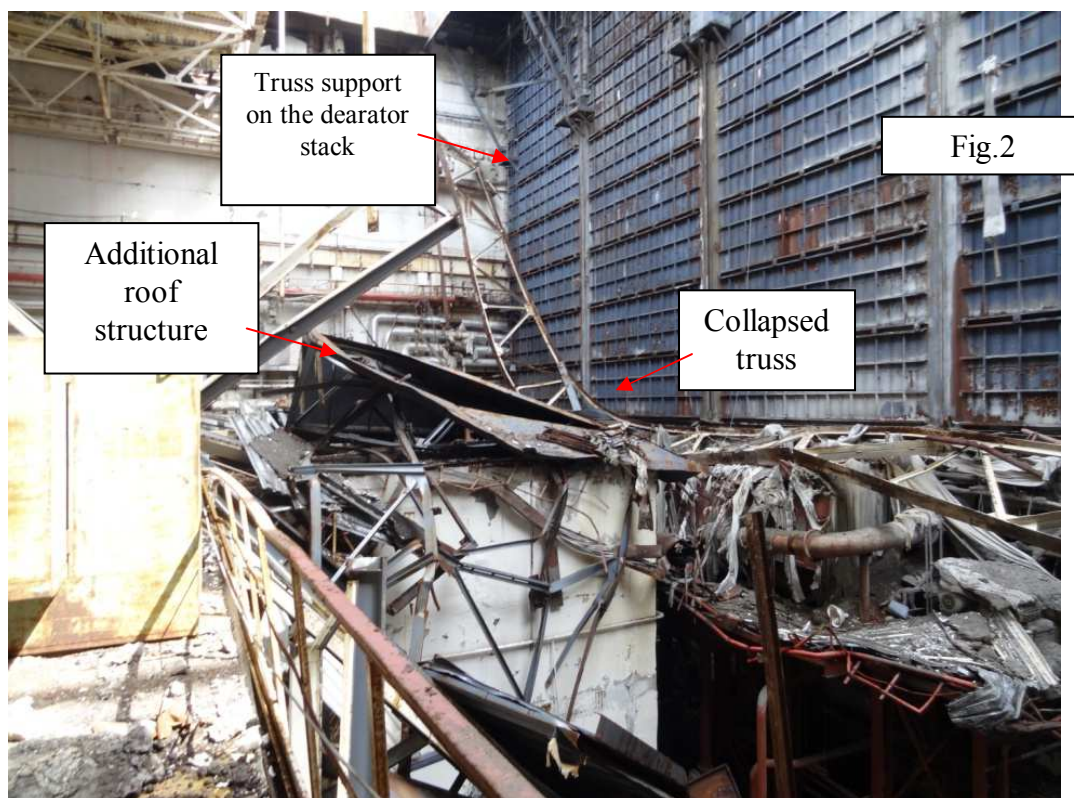
During the roof truss failure, its bearing node on the deaerator stack structure on row B side wasn't destroyed. As a result, the fallen roof truss is partially supported and hanging to the deaerator stack structure.

Figure 2 Turbine Building inside view of main floor area under collapsed roof section

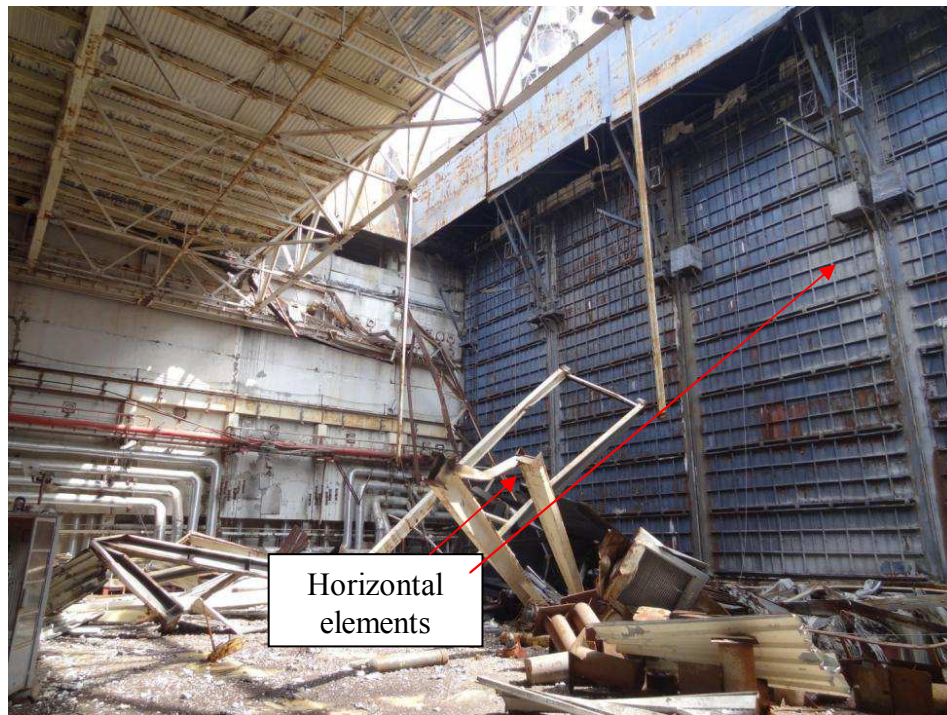
Fig.3

Collapsed roof truss was connected with bracings on the bottom chord with trusses in axes 52. During failure its junctions with bracings were destroyed (Fig. 3)

Figure 3 Turbine Building view of area of collapsed roof section

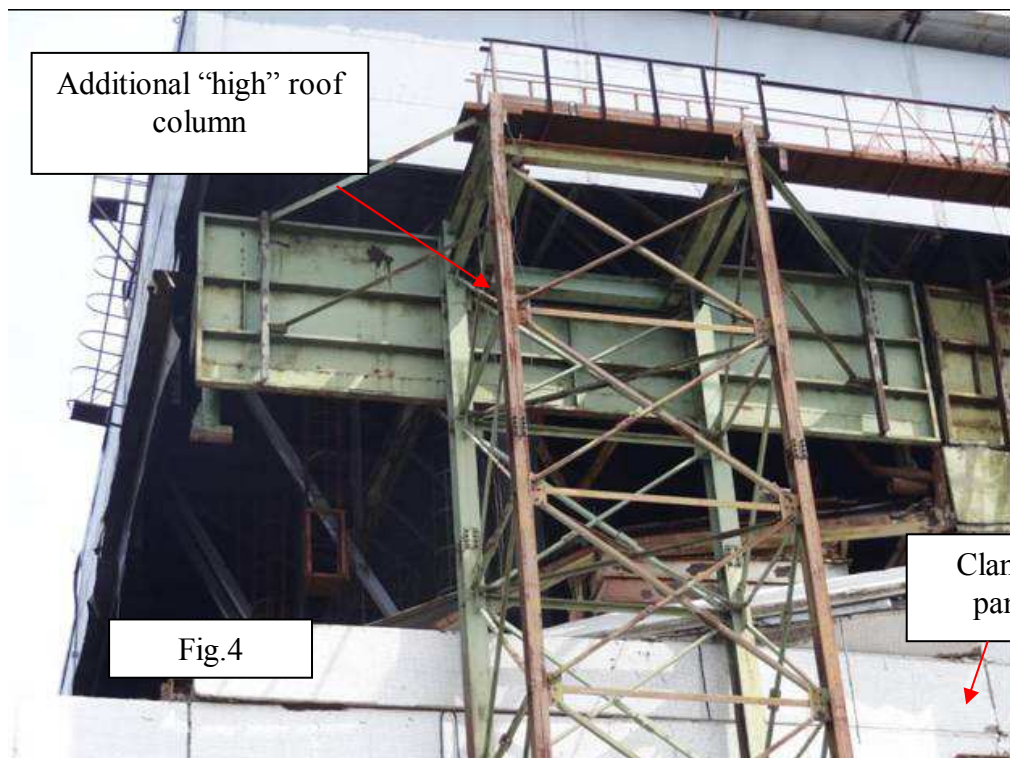
Along with the roof collapse complete or partial collapse of wall panels (~ 20 pieces) occurred in the zone of fallen roof truss support on a column along gridline A. Part of these panels collapsed to the ground, some panels were stuck in unstable position, partly relying on neighboring structures. Another part of the unstable panels has been removed by plant's personnel using the jib crane. Part of the unstable panels were not accessible for the crane due to close location of spatial structure supporting additional "high" roof, built over an intensively damaged roof area of the Turbine Hall after the accident from 26.04.1986.

Figure 4 Turbine Building view from outside of wall panel failure in "high" roof zone next to gridline 50

- In order to avoid overloading of the construction, to dismantle damaged wall panels on row A between the axes 52 - 46 in two phases: within the first phase to dismantle the wall plates between axis 50-52 and in axis 48 and within the second phase to remove all other plates after detailed survey [8].

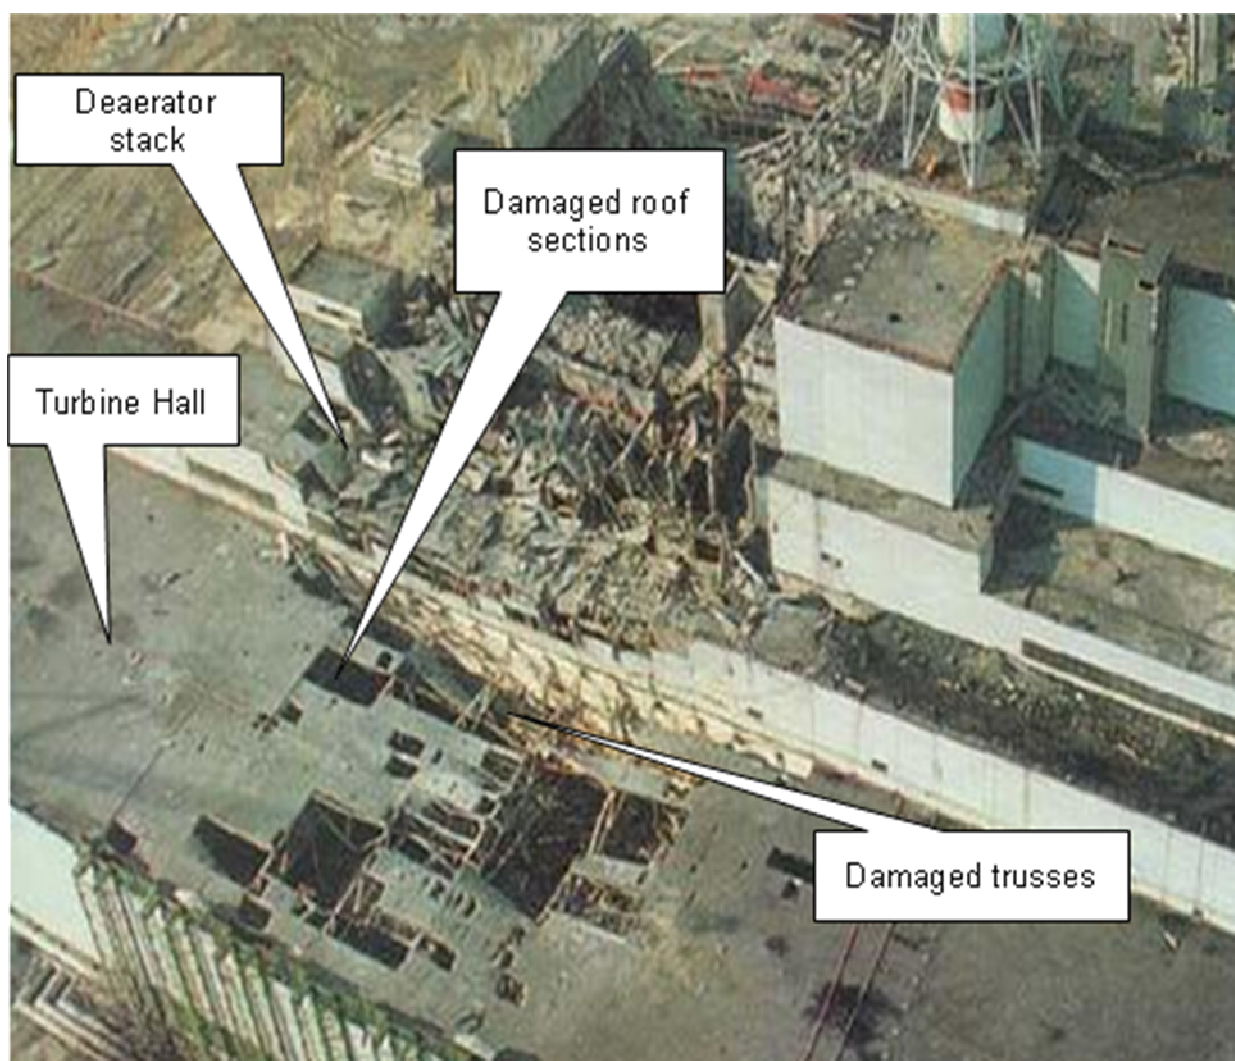
During the 26.04.1986 accident not only Reactor Building, but also some Deaerator Stack and Turbine Hall structural elements were seriously damaged (Figure 7).

Figure 7 Damages to ChNPP generation II structures (Units 3 and 4) as a result of the accident

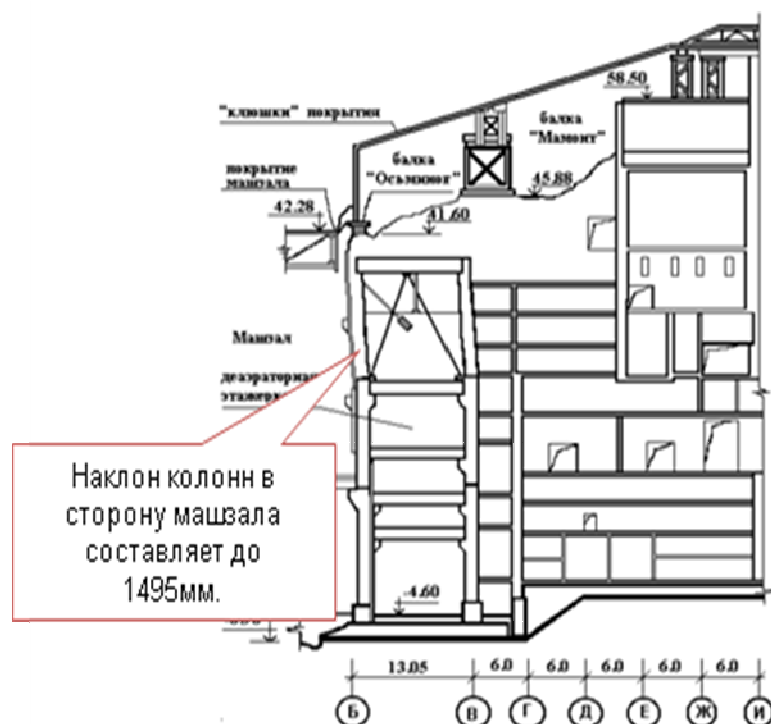
The Turbine Hall roof was not only damaged, but also highly contaminated with radioactive particles ejected during reactor explosion. The Deaerator stack structures (Fig. 8), being the supporting structures for the Turbine Hall roof trusses were significantly damaged at places. Especially seriously were damaged the roof elements in gridlines 40-50, i.e. in the area closely adjacent to Unit 4 Reactor Building.

Figure 8 Deaerator stack structure damages

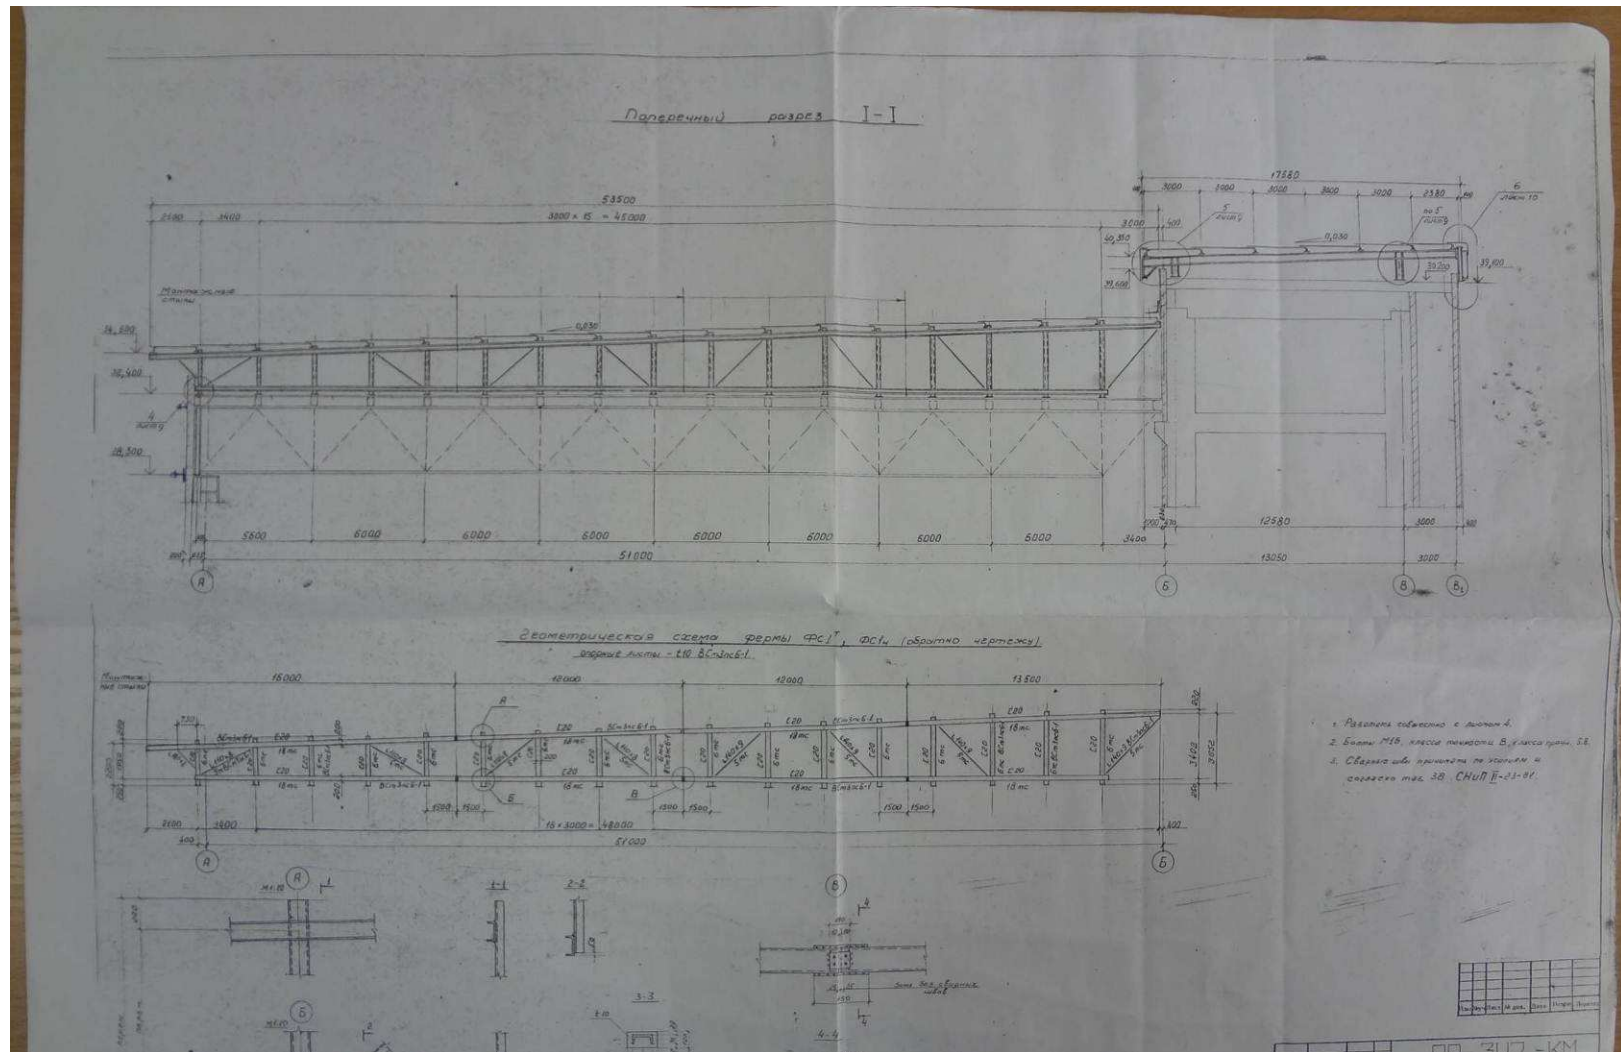
Additional "high" roof is built in the area of very intensive damages. In this zone, it was not possible to rely on the bearing capacity of damaged roof trusses and columns. In this regard, in the Turbine Hall in axes 41 and 49 monolithic reinforced concrete walls were built. New trusses were installed on the walls on which "high" roof was placed.

Figure 9 Transverse section of second roof structure in “low” roof area
