TO THE 30-th ANNIVERSARY OF SHELTER
CONSTRUCTION AND OPERATION

**30 YEARS OF SHELTER
YEARS OF FEAT**

State Specialized Enterprise Chornobyl NPP

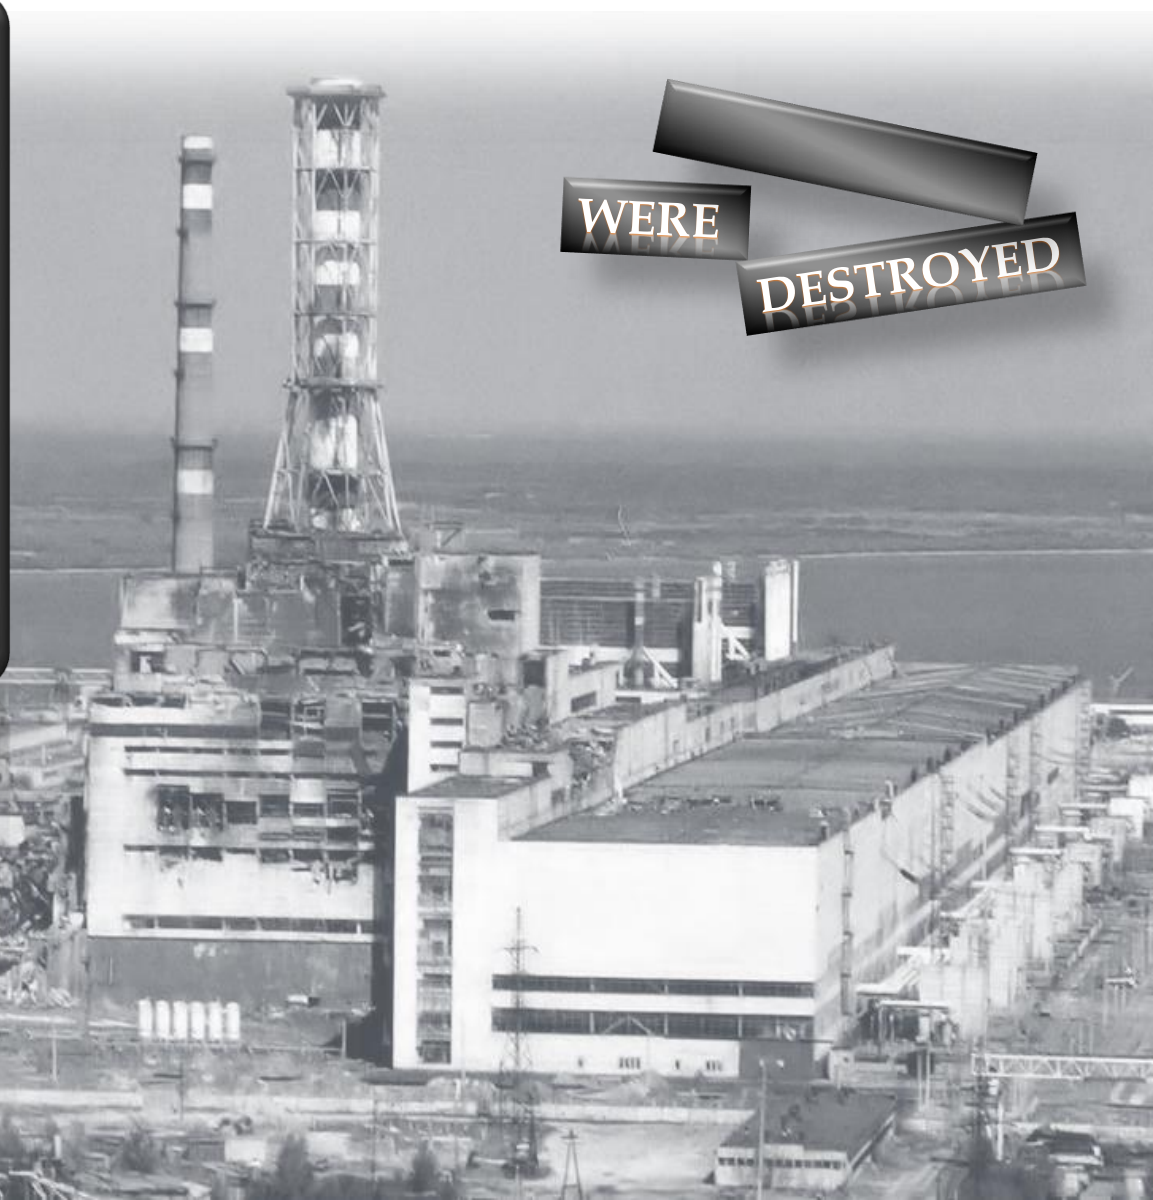
**Turbine Hall
(Block "Г")**

**Deaerator Stack
(Block "Д")**

**Reactor compartment
(Unit "Б")**

Bladder type building of ECCS

Block "RCAS"

**WERE
DESTROYED**

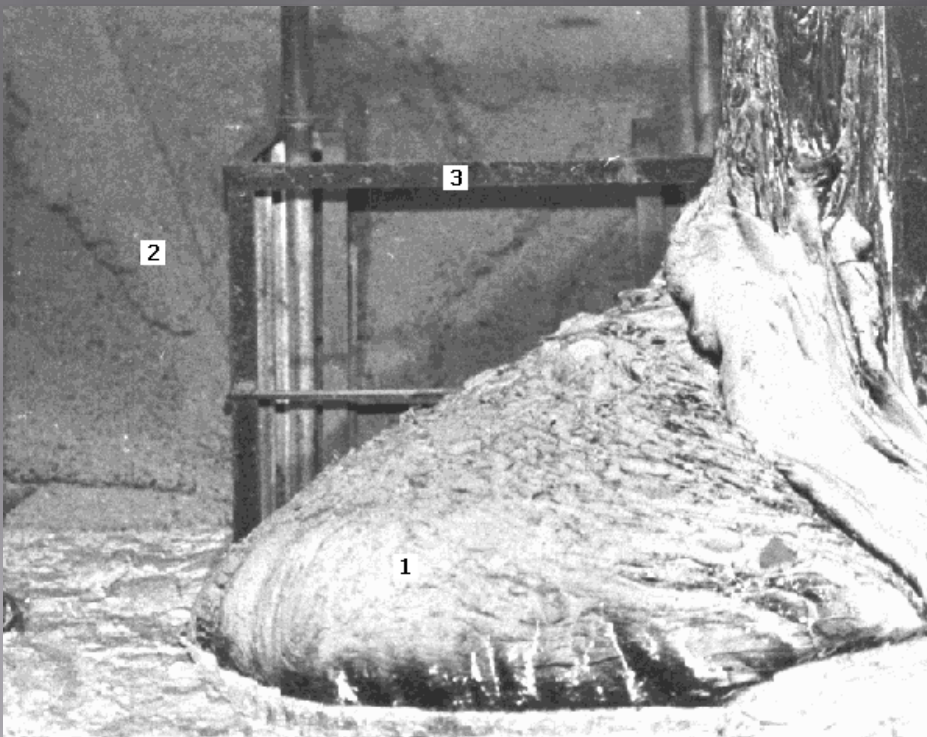
One of the first pictures of “Elephant foot”, the upper part is integral here, the surface is glass-like, shiny.

- 1 - main lapping of EF;
- 2 - a stream of “fresh” concrete of 1986;
- 3 - passage enclosure in the floor at level 3.00.

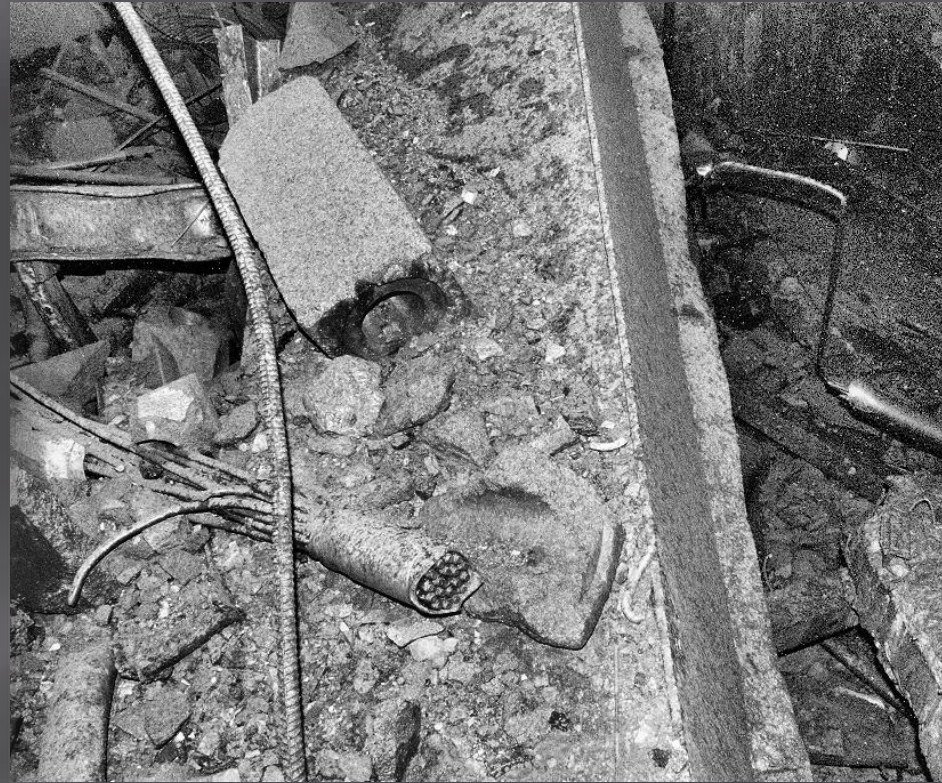
In the middle of power unit 4 Central Hall.
A graphite block from reactor stack , a piece of fuel assembly is close to it

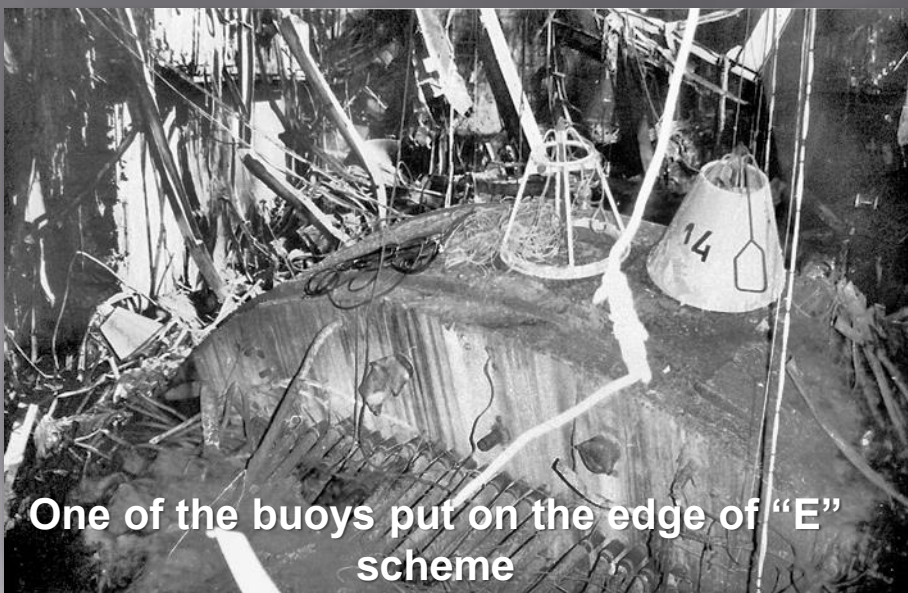
One of the buoys put on the edge of “E” scheme

Sensors inside the buoy.
 Symbols in the picture:

- 1. Sensors of heat flux density.
- 2. Thermometers.
- 3. Sensors of gamma-radiation dose rate.
- 4. Air-flow meters.
- 5. Communication boards

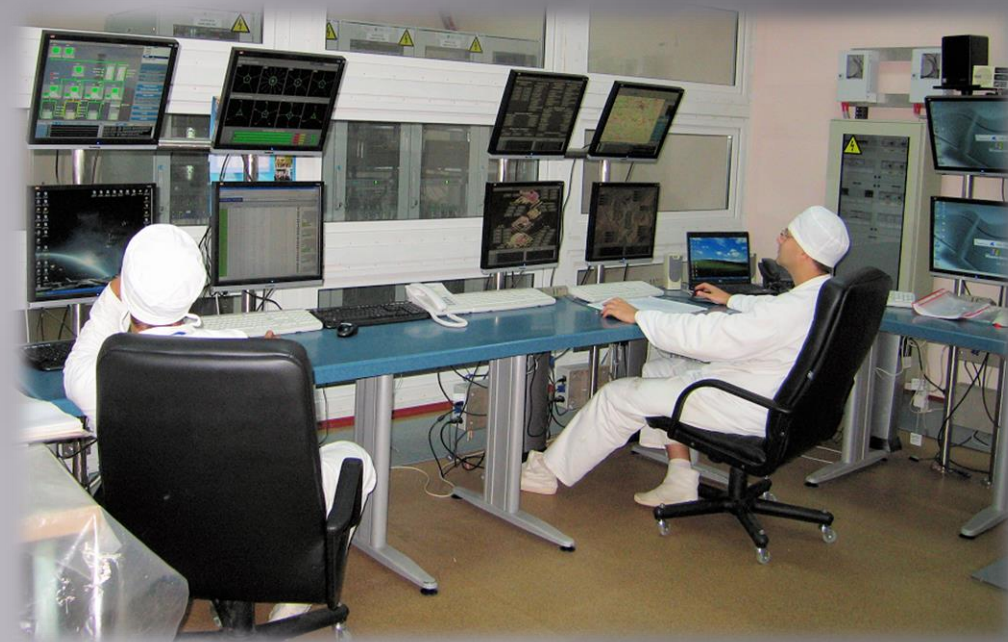
Схема размещения датчиков СКЯБ

Integrated automated monitoring system (IAMS)
provides

- FCM condition monitoring;
- Radiation monitoring in the premises and area of Shelter, control of Shelter RS emissions;
- Building structures condition monitoring;
- Seismic control

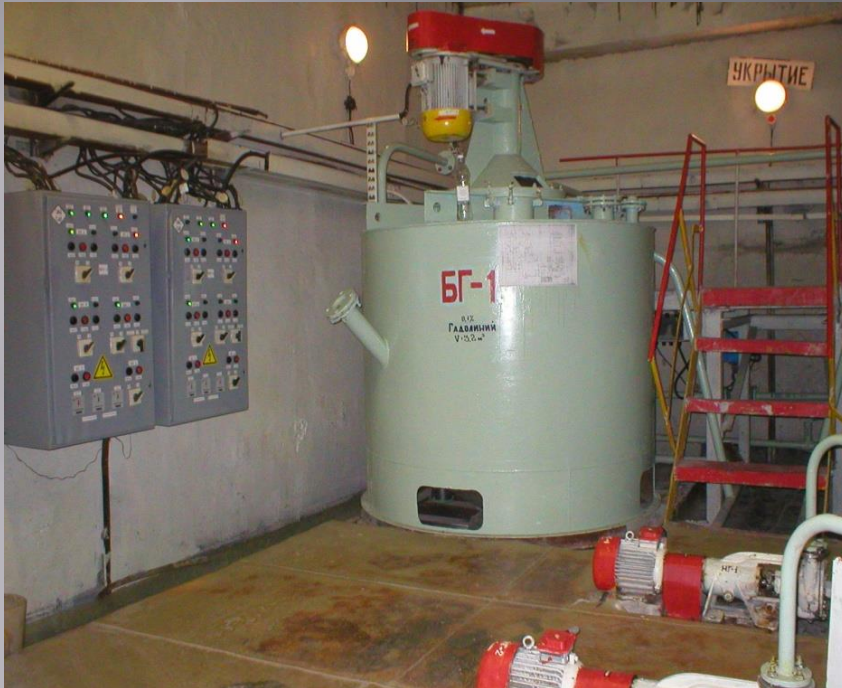
Gadolinium solution feed system is intended for supply of NAS to Unit 4 Central Hall debris

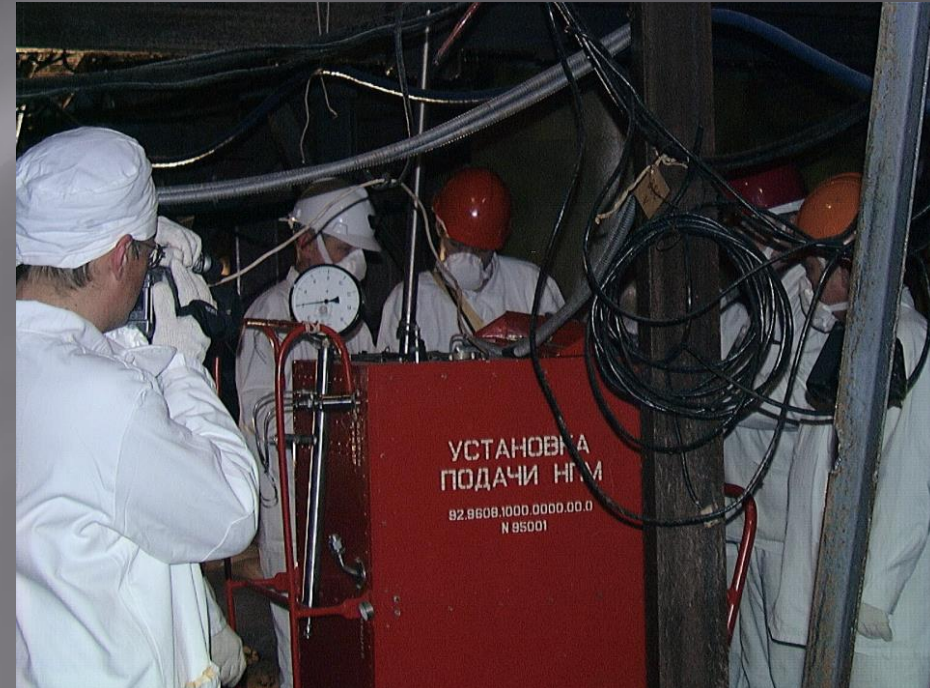
Prompt feed unit for neutron absorbing solution "ЮК СОБГ-40" is intended for NAS supply to Shelter under-reactor premises

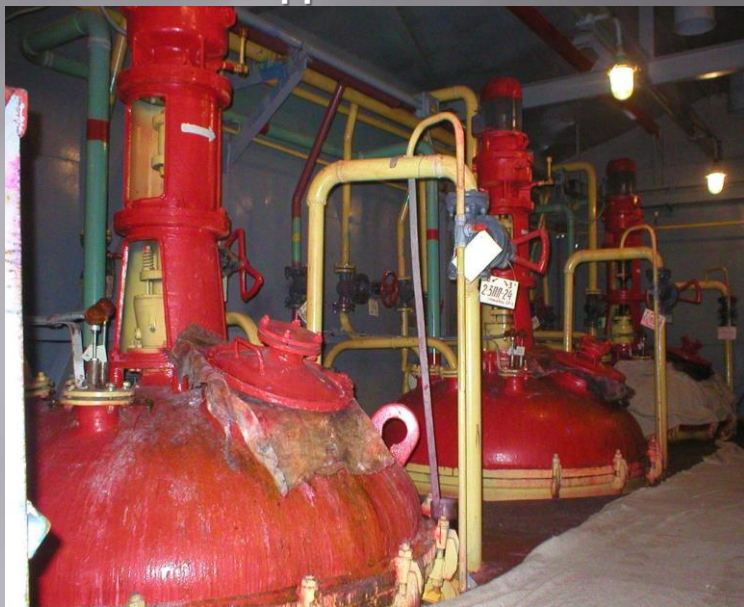
Upgraded system of dust suppression is intended for localization and suppression of radioactive dust within Unit 4 CH debris

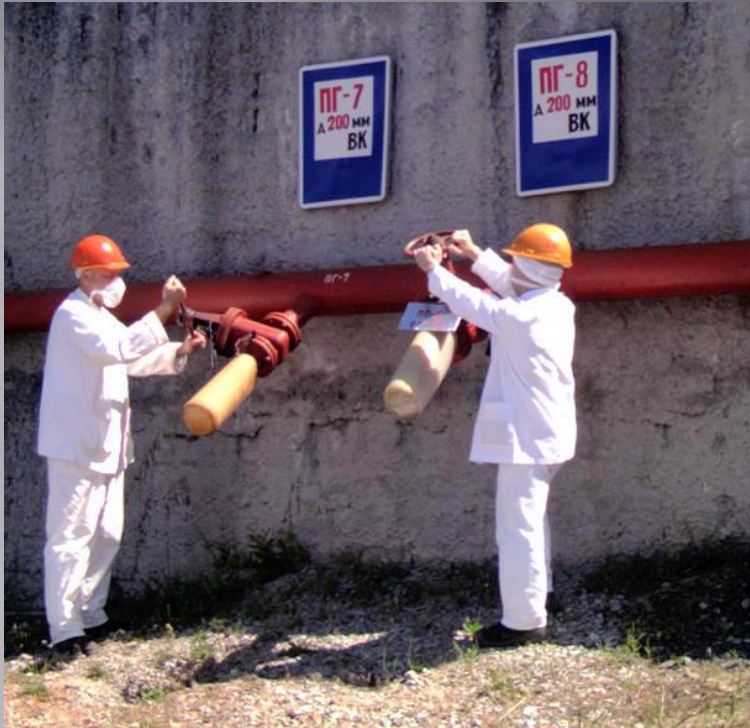
Fire fighting equipment:

- automatic fire alarm units in the Shelter premises
- automatic gaseous fire suppression units in electrical rooms
- automatic powder fire suppression units in Shelter ventilation centers
- water-based system “Suhotrub” for fire extinguishing in Shelter rooms, on its roofs and within the local area
- fire stops and fire-proof doors

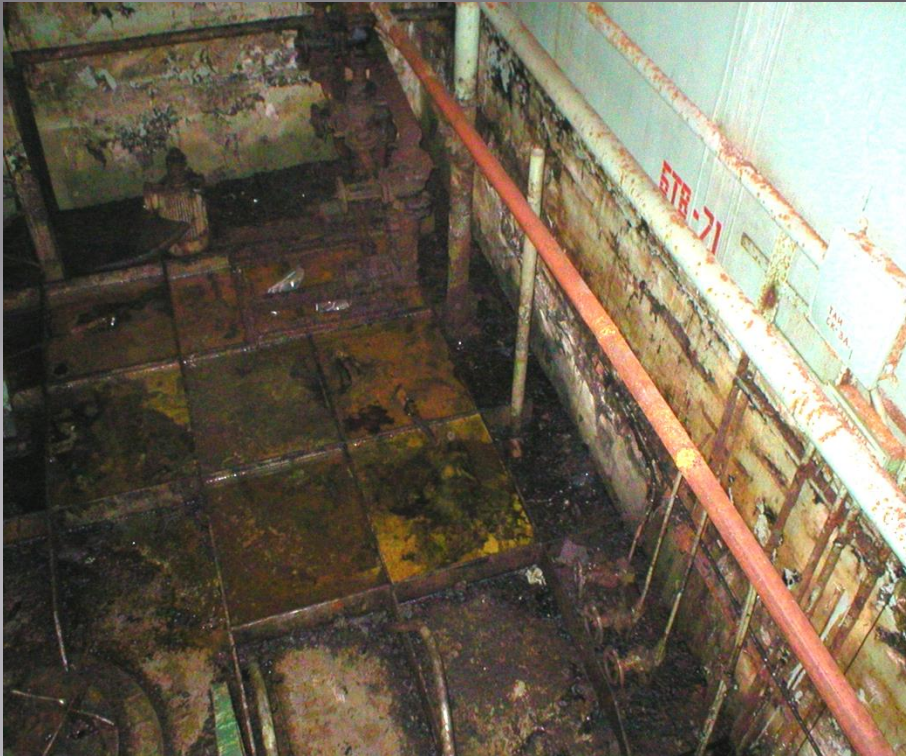
Management of liquid radioactive waste (LRW)

Within 2016, about 3,500m³ of radioactively contaminated water (RCW) have been collected and pumped out from Shelter premises for processing.

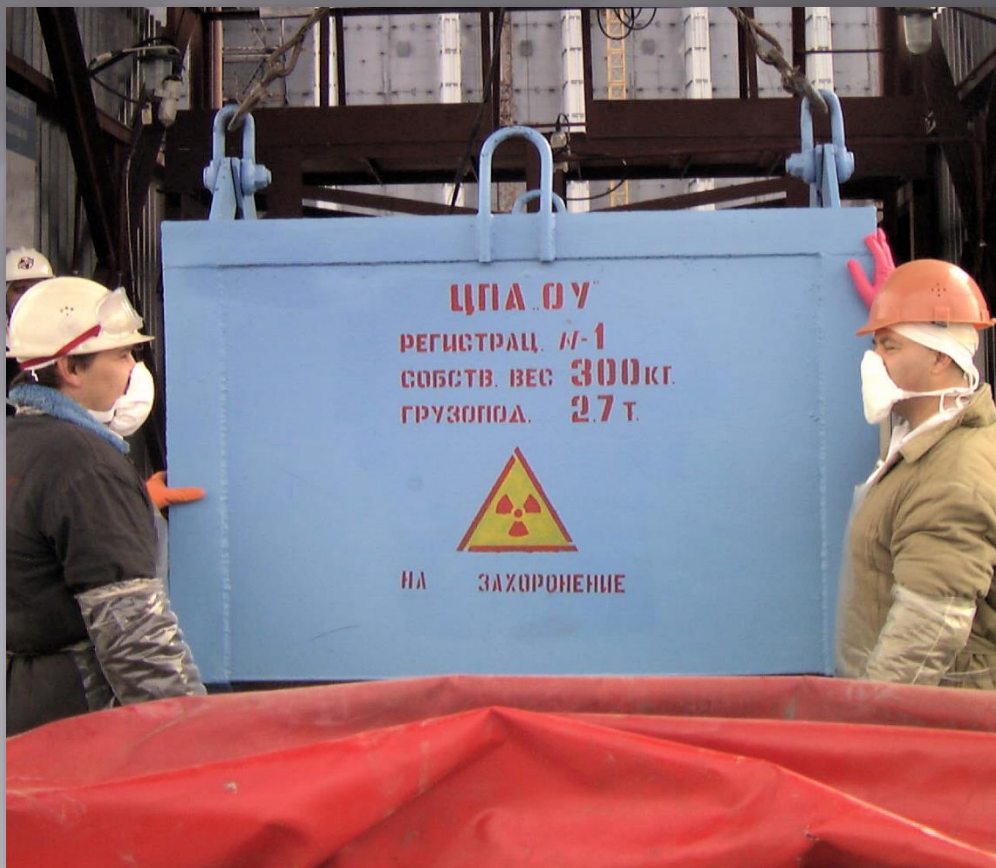
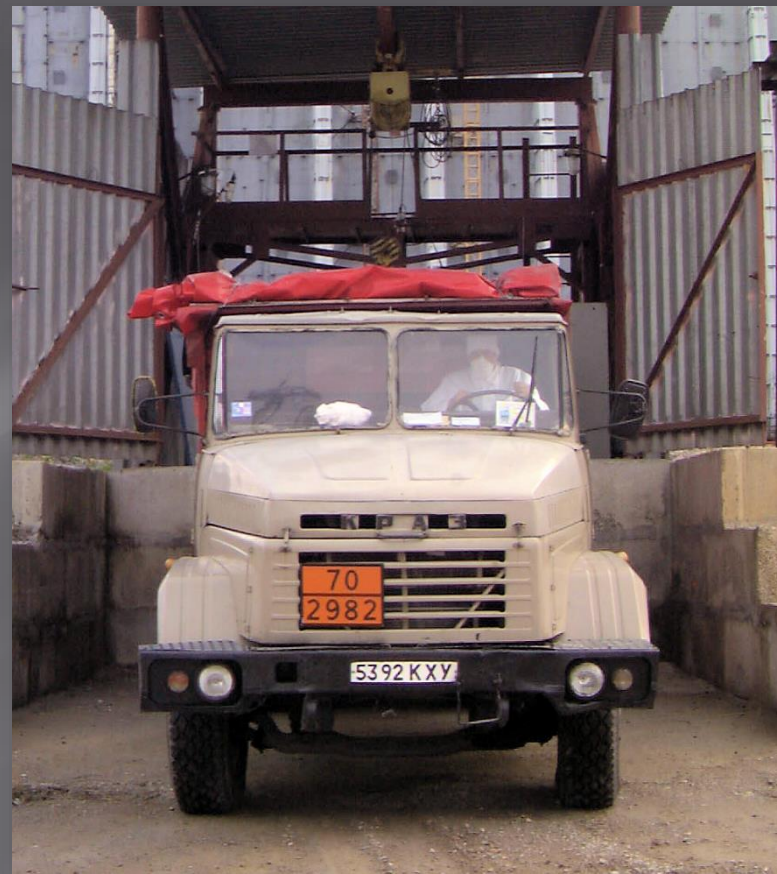
Management of solid radioactive waste (SRW)

Within 2016, 6000 m³ of low- and intermediate-level SRW have been collected, sorted out and removed for disposal, and 8 m³ of high-level SRW have been placed for interim storage.

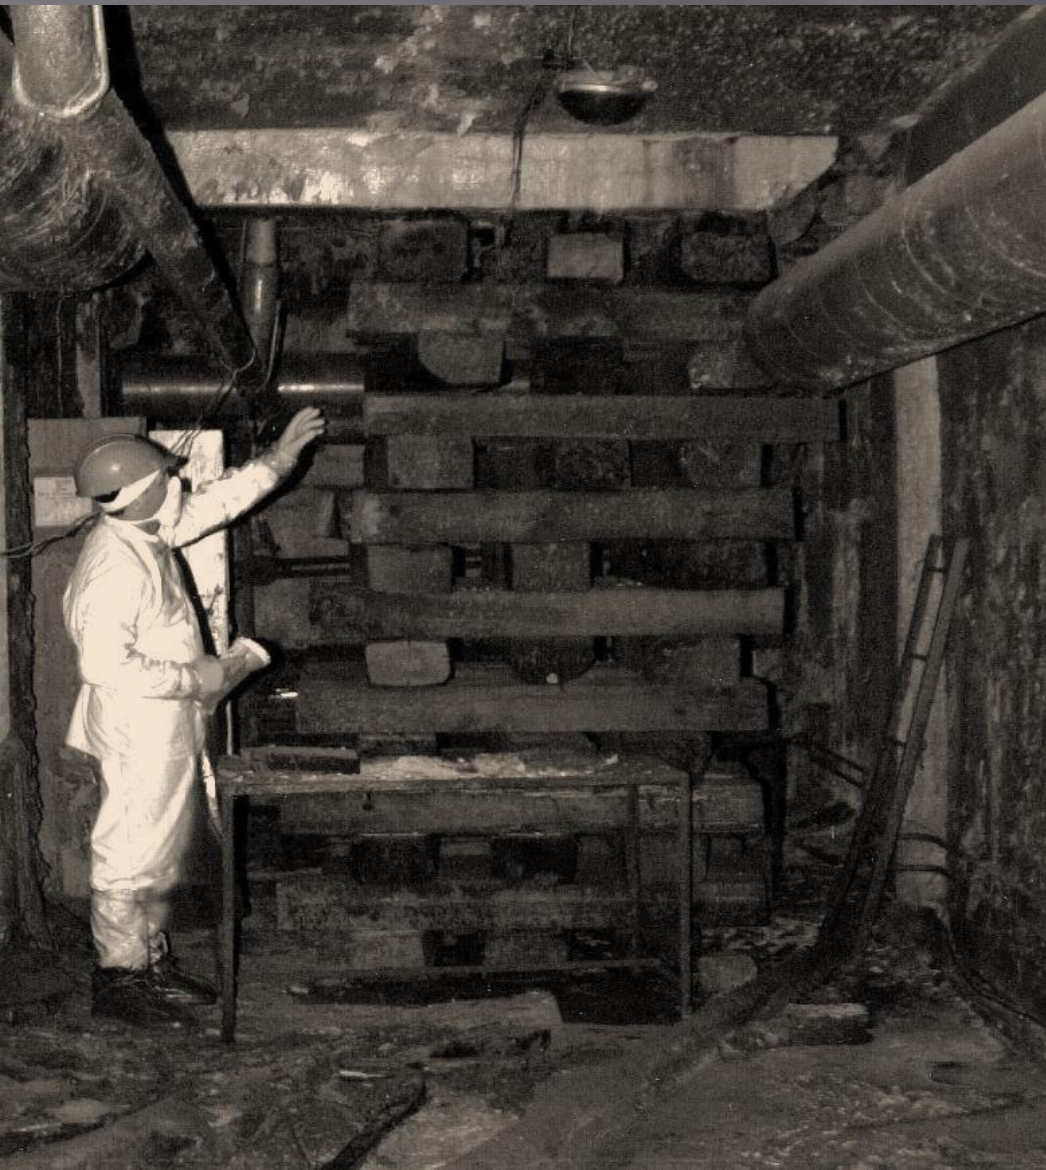
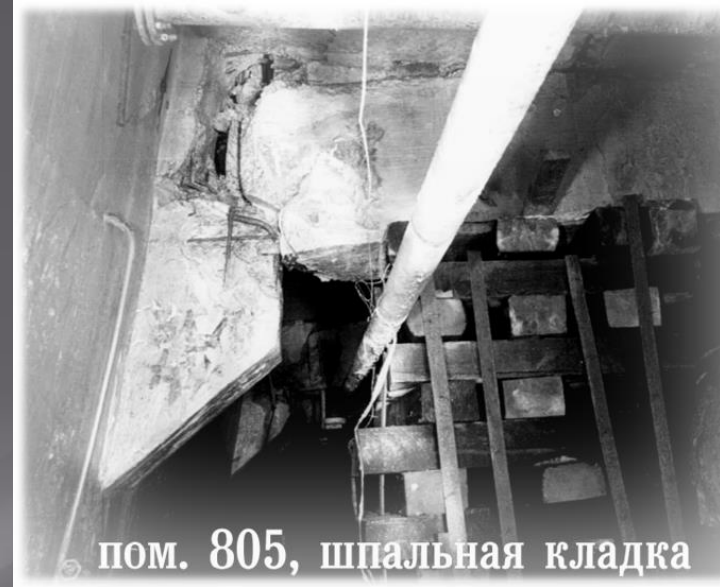
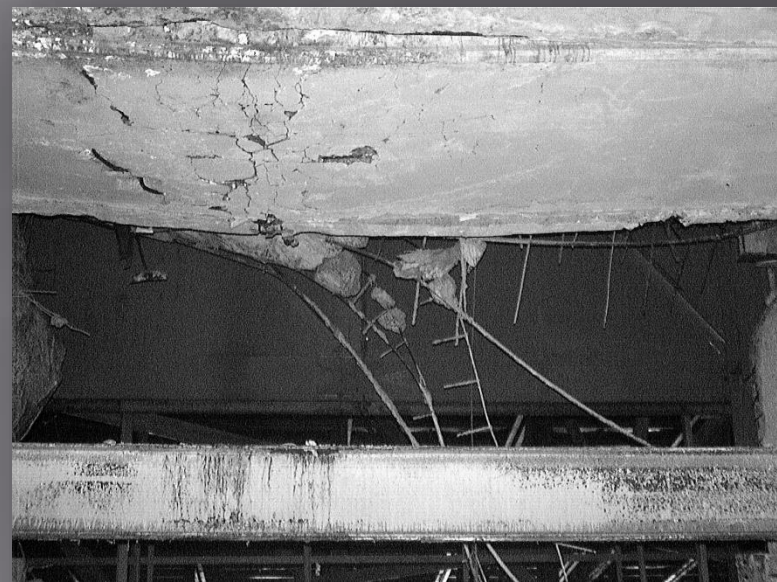
2013. Collapse of the building structures. On February 12, 2013, the roof structures of Generation II Block “Г” Turbine Hall within the axes 50 – 52 between rows A – Б as well as the wall slabs along row A of axes 48-52 collapsed at 14:03
