IAEA MISSION ON PARTIAL COLLAPSE OF TURBINE HALL ROOF OF UNIT 4

**Chernobyl NPP, Ukraine
03–07 June 2013**

**Review of activities performed by ChNPP and analyses of perspective causes of
the Unit 4 turbine roof failure.**

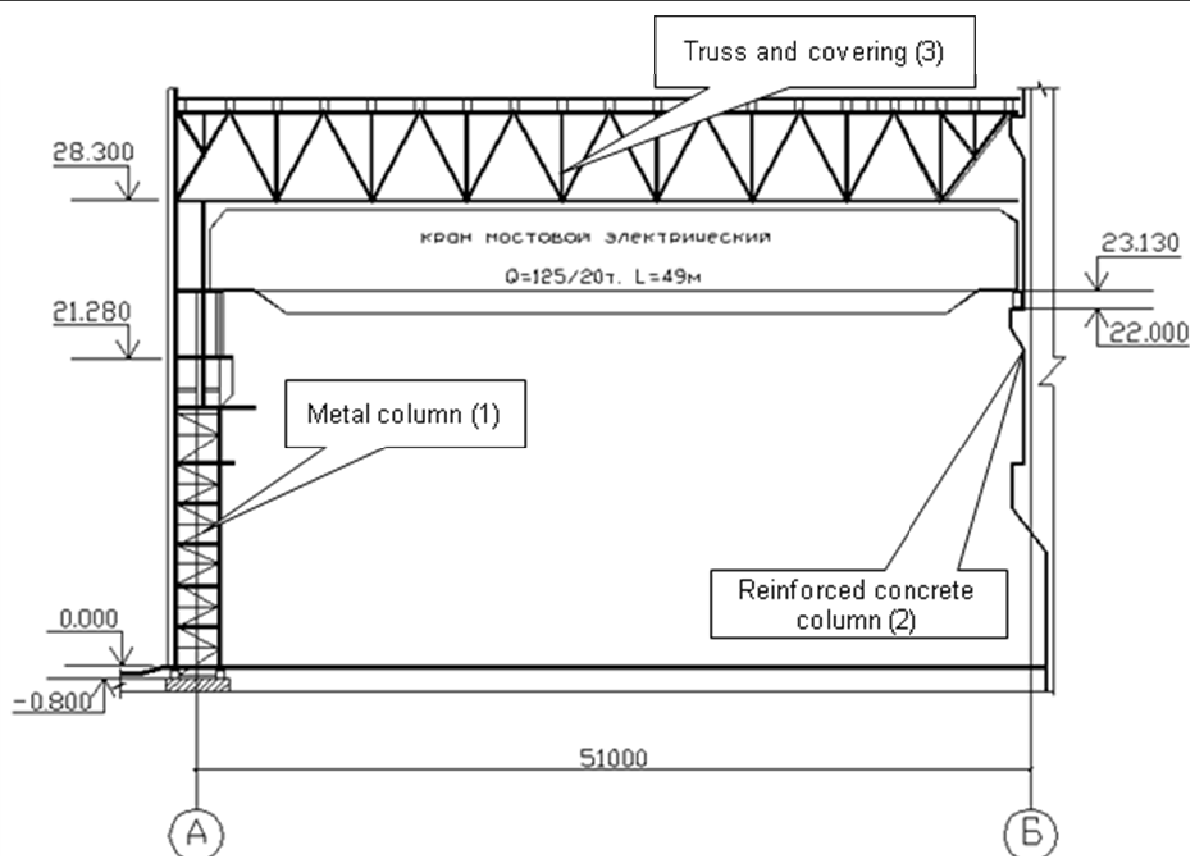
Figure 6 Section of ChNPP part II (Units 3 and 4) Turbine Building

The turbine hall roof considered in this report has also an additional roof (double roofing) in axis from 36 to 40 and from 50 to 68 of Unit 4 roof. In addition the Unit 4 Turbine Hall roof construction between the axes 41- 50 is considered as the critical building construction which has a special roof (third roof). This particular part of turbine hall roof is one of 17+8 specially important “Object Shelter” structures that went to thorough assessment and inspections to ensure that it will retain its functionality within 15 years.

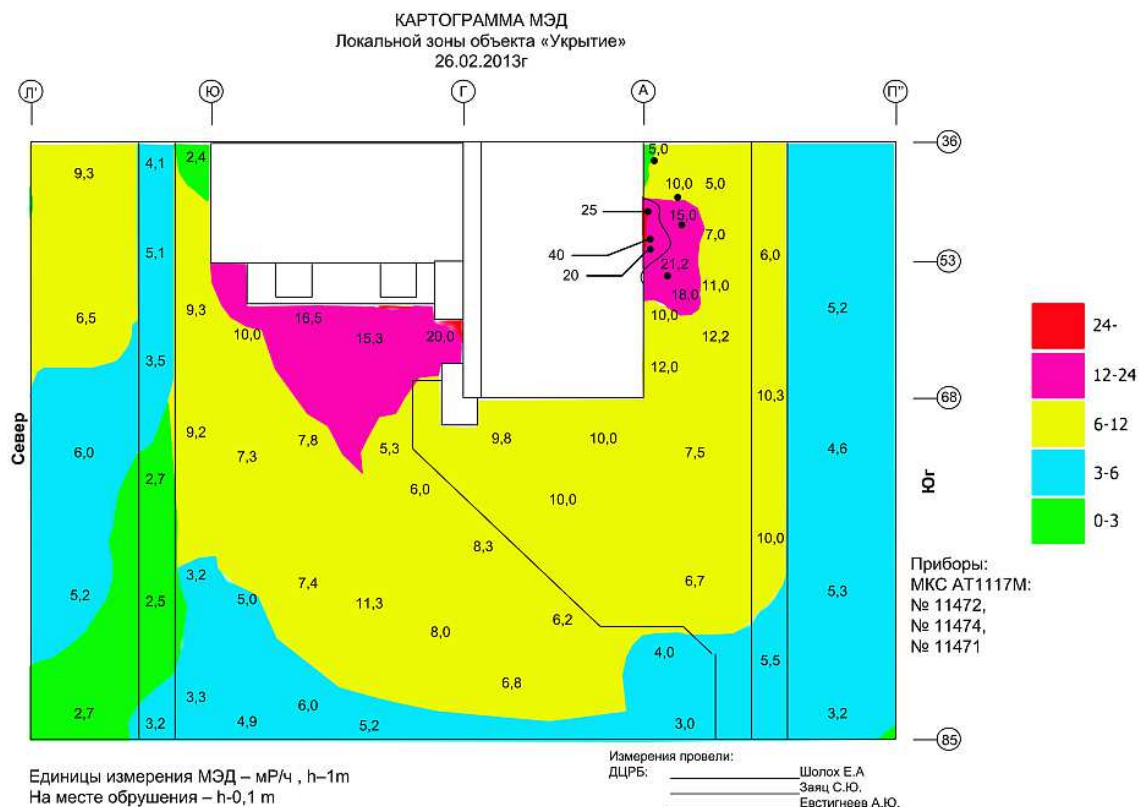
Figure 10

- According to the reading of automated monitoring system it was also confirmed that the dose rate values did not exceed the reference levels.
- The dose rate and surface contamination measurements were completed by air concentration measurement (for Cs-137 and Am-241) on 38 point of the site. It follows from the results that the increase of airborne activity in the SO premises was short – timed and it was resulted from wall panels and partly from light roof collapse of Unit 4 Turbine Hall. Following the results of scheduled air monitoring in the SO Local Zone as of February 13 and 14, no reference level for beta and alpha long – lived nuclides mixture volumetric activity was exceeded in general.

- The monitoring program is being performed every day controlling the dose rate, surface contamination and air contamination.
- Dose rate measurements were performed during the walk through and good agreement was found with the results of the monitoring team.

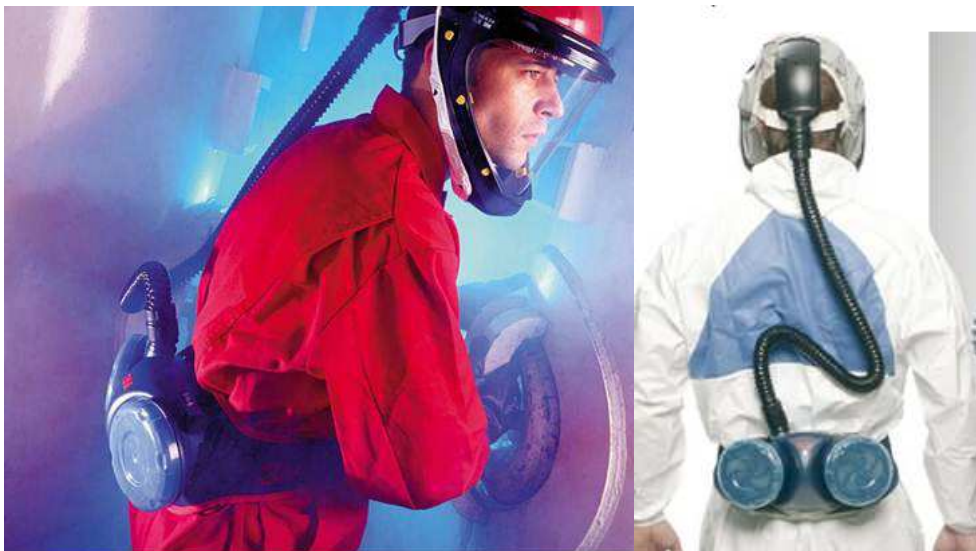
Figure 11 Example of ventilated masks

An additional measure to improve the working conditions during the work inside the turbine hall buildings (such as already used for works in other highly contaminated areas at ChNPP), could be use of vented masks with particulate filters. This may contribute to reducing the possibility of internal exposure and to increase work efficiency and related reduction of the time spent in the high-radiation zone. An illustration below indicate vented mask that is light weight and easy to carry.
